TECHNICAL REPORT CERC-92-5

# A STUDY OF GEOLOGIC AND HYDRAULIC PROCESSES AT EAST PASS, DESTIN, FLORIDA

Volume I

Coastal Engineering Research Center

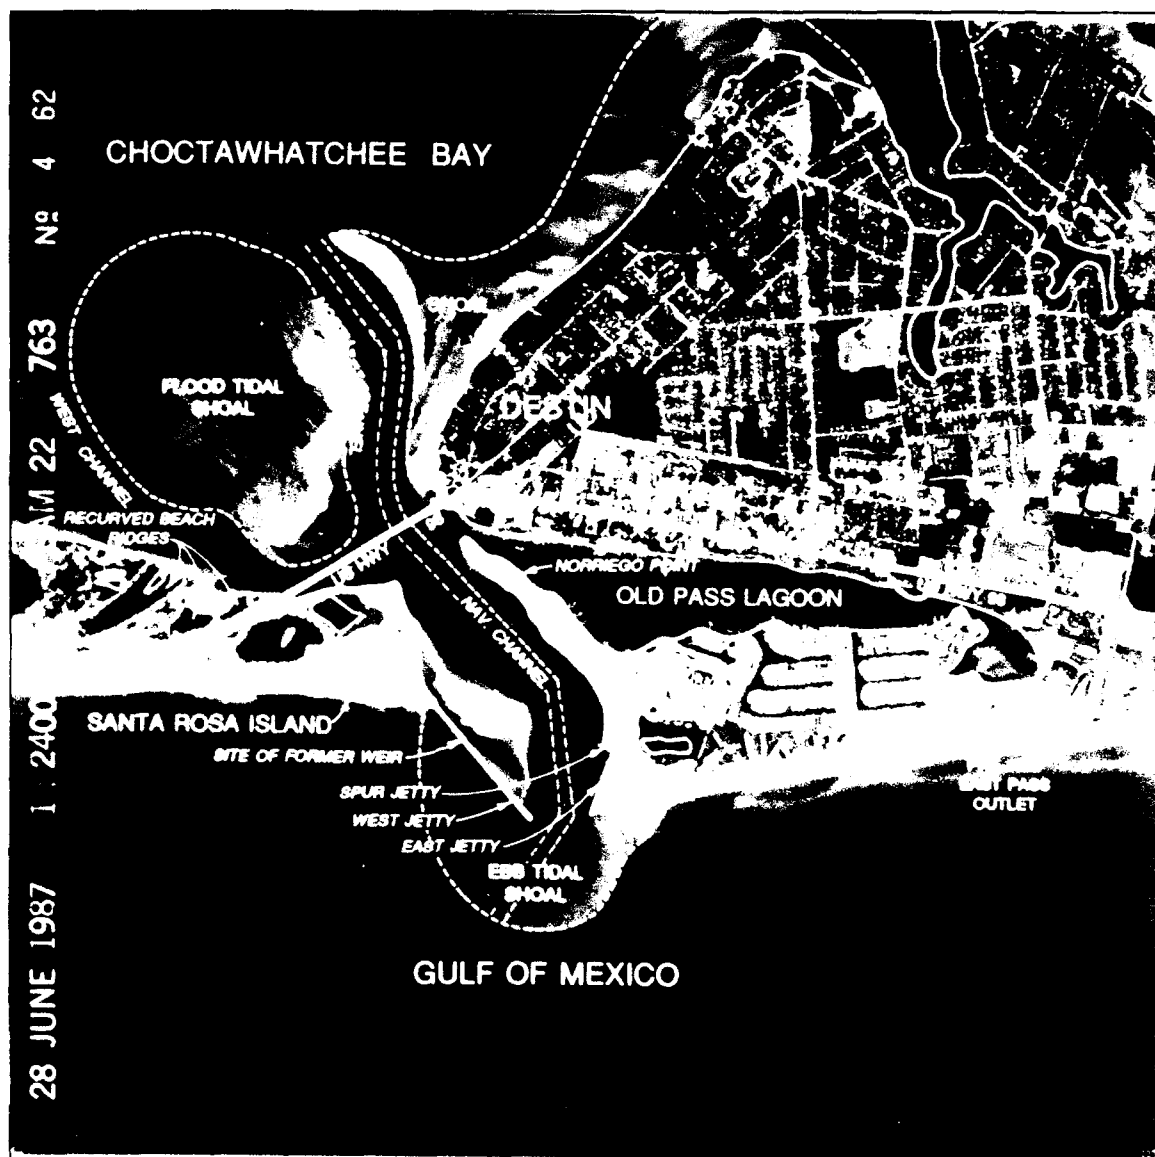
Figure 3. Aerial photograph of the East Pass Area, 28 June 1987; one of a series taken during the East Pass monitoring project

General rehabilitation of the project was performed in 1977 for \$278,000 (Sargent 1988). A major part of this effort was the construction of a 300-ft-long rubble-mound spur at the landward end of, and perpendicular to, the east jetty (Figure 3). The purpose of this groin was to divert the flow of the inlet's water away from the landward end of the east jetty because the beach immediately to the north had been cut back. If the erosion had continued, it was feared that the main jetty would be undermined. Ironically, the inlet was behaving as if it were trying to reoccupy a northwest-southeast-trending channel that it had followed in the 1950's and 1960's which had been specifically blocked by a sand dike when the east jetty was built (details of the inlet's meanderings will be discussed in Chapter 3).

Under the scenario that the net drift is to the west, the dynamic behavior of East Pass implies that it is migrating updrift. Updrift migration has been reported in the literature (Aubrey and Speer 1984, Carter 1988, FitzGerald 1988). An alternative scenario is that there is a localized drift reversal in the vicinity of East Pass. Levin (1983) noted that there was geological evidence of an anomalous eastward sediment transport in this region. The southwest-northeast orientation of the beach ridges on the eastern end of Santa Rosa Island (Figure 3) indicate that this part of the island grew from west to east.
